MEETING AGENDA
BMP Retrofit Pilot Program Quarterly Status Meeting No. 16

**Qualification Statement for the Stormwater Management StormFilter
for the Caltrans Kearny Mesa Maintenance Facility**

Qualification Statement for the Stormwater Management StormFilter for the Caltrans Kearny Mesa Maintenance Facility

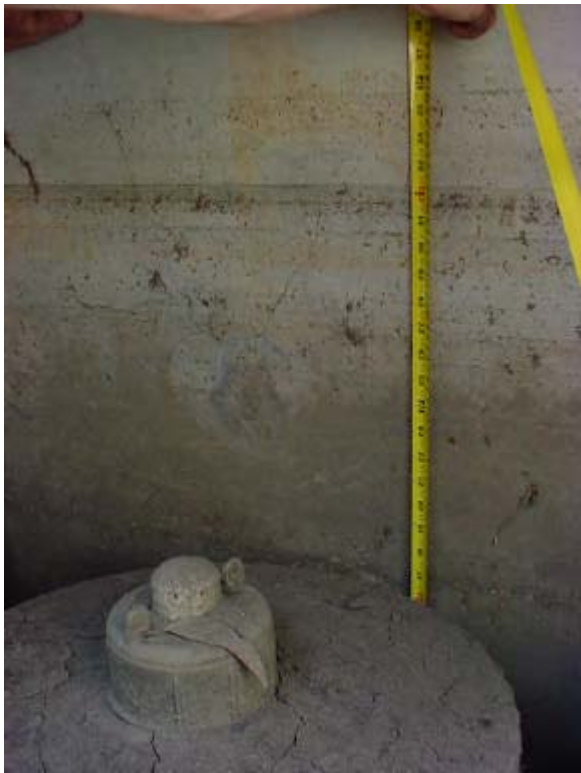
- High Water marks

There are a series of high water marks evidenced by small pieces of flotsam attached to the vault walls. The high water marks are significantly above levels the filters are designed to handle. Based on the observations it appears that two storm events may have caused this condition. There are about 8 high water marks in the vaults but multiple marks can be caused during the course of a single storm event. In fact, inflow hydrographs clearly indicate intermittent inflows causing multiple peaks during a single storm event.

It is surmised that two separate storm events caused the mark from the content of the high water marks. The highest marks were comprised of small bit of wood debris and leaf matter. The visual appearance of all but two of the high water marks have the same debris content and characteristic, hence it presumed this was caused during the course of a single storm. The maximum height of the water surface elevation indicates about 12" of head

on the overflow which means the system was overflowing at about 1 CFS. As expected, moving from the downstream overflow point to the upstream vault, the WSE increased in a manner consistent with the head loss characteristics of the vault connections and appurtenances.

The second storm that super elevated the WSE is evidenced by distinct lines where plant pollen (probably originating from the adjacent trees) adhered to the sides of the vault. This event super elevated the first vault only since the high mark for the "pollen storm" did not reach the invert of the pipe that connects the middle and downstream vault

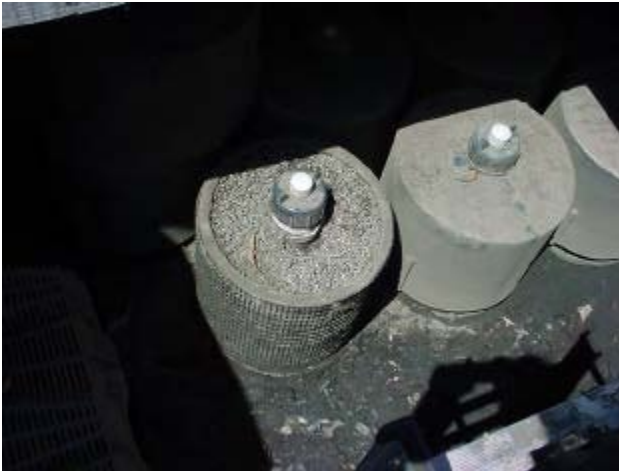
- Sediment Loads

Sediment deposits on the floors and outer surfaces of the cartridges were also observed. The upstream vault had an estimated 1" of a highly organic sediment on the floor of the vault. Close observation of this sediment revealed leaf imprints leading to the conclusion that it was composed mostly of decayed eucalyptus leaves. The media inside the cartridges was very dark with a high degree of occlusion. Clearly the first vault is past due for maintenance.

The middle downstream vault had moderate loading of mostly sediment. The characteristic of the sediment in all the vaults was that sandy sediments were in the upstream vaults moving to a fine silty characteristic in the downstream vault.

The floor of the upstream vault is coved with about 1.5” of a fine organic layer of composted eucalyptus leaves. This is evidenced by the large number of eucalyptus trees around the maintenance facility and careful observation of the black organic layer reveals leaf imprints.

Due to the degree of sediment loading and presumed saturation of the CEC, a full system maintenance is recommended. At the time of maintenance, the entire system will be upgraded to the current technology consistent with SMI policy.

The heavy leaf load incident to the filters could be intercepted with screens and cleaned out on an as needed basis. This reduction would improve the performance of the system and reduce maintenance costs. This can be accomplished by installing some netting similar that to manufactured by Enviropod or other catch basin insert manufacturers.

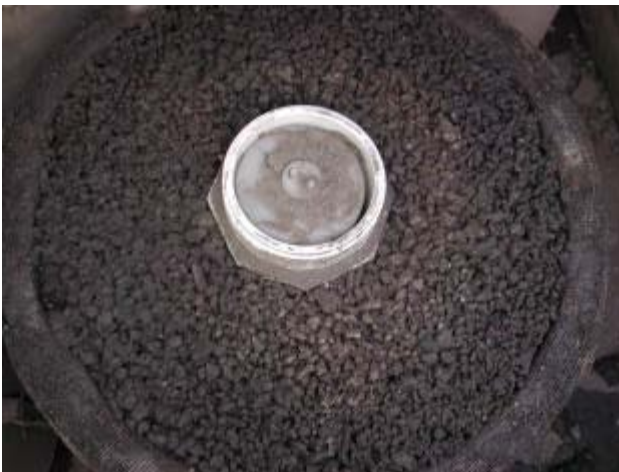
- Condition of filter media

The tops of the cartridges were removed in all three of the vaults. Within each vault the cartridges appeared to be uniformly and equally loaded with solids. However the cartridges in the upstream vault were clearly more heavily loaded than those in the downstream vault. This is primarily due loading from smaller storms only being in the upstream vault(s) and that the upstream vault acts as a pretreatment to the downstream vault(s). The photo to the left shows a

top view of a cartridge in the upstream vault with the hood removed. The media (normally white) is heavily loaded with solids from the runoff. The media in the downstream vaults was less loaded and was more of a light brown, probably because there were significantly less organics (from the leaves) in the two downstream vaults.
